7 Every Avenue, Over There, NY  
Confidential Report. Prepared for the Exclusive Use of (your name goes here)  
Date of inspection

**Clear Creek  
Home Inspection Services  
PO Box 565, Collins, NY 14034  
716-864-1231**

**Inspection of 7 Every Avenue  
Prepared for (you)  
Date of inspection  
4:15-7:10 pm  
77° F, Sunny**

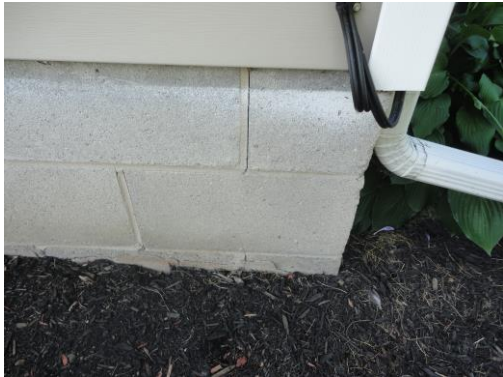
- 1. There are shrinkage cracks in the mortar joints at all but one outside corner of the foundation. These cracks do not extend to the interior yet, but could if they are left untreated. Chip out the mortar and replace it with new material. This could easily be a DIY project.**

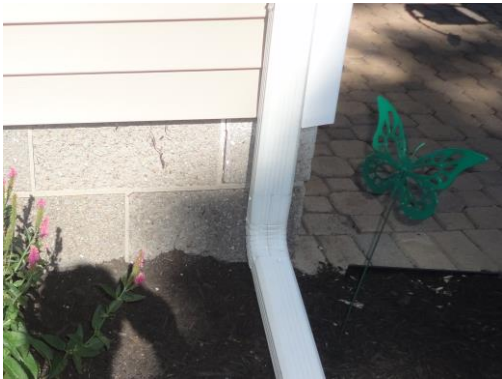
- 2. The corner that has not cracked is badly spalled. The surface has eroded and will need to be repaired by parging (plastering on a new surface). I recommend fiberglass reinforced Block Bond or Top and Bond with a latex modifier. You will need to go to a masonry supplier for these. This could also be DIY but will be more challenging than the last repair. A good mason could do both in an afternoon.**

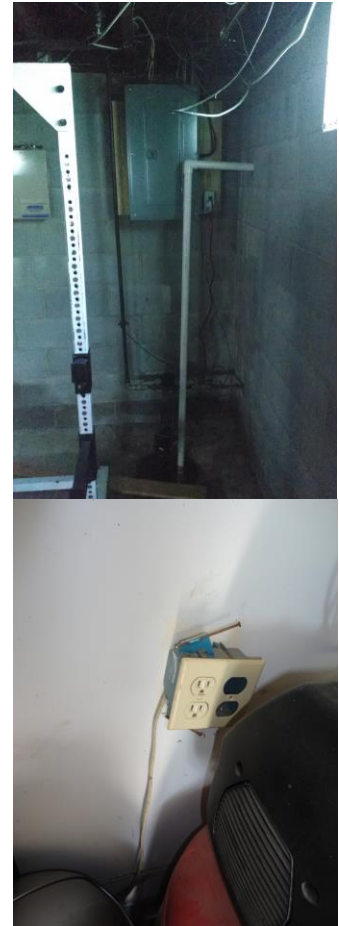
The electrical panel has been updated and a few new branch circuit wires added. It was placed in the same odd location as the original, very high and directly over the sump pit. The sump pump discharge pipe is in front of the panel cover making it difficult to work in the panel and actually prevents the door from opening fully.

- 4. The sump pump discharge pipe should be rerouted so that it does not interfere with the electric panel cover. There should also be a cover over the sump pit to keep anyone working on the panel from falling into it.**
- 5. There are GFCI outlets all over the house, including an odd one in the master bedroom, but a few are missing. Add GFCI protection at the kitchen counter near the sink and in the garage, either with GFCI receptacles at those locations or with GFCI breakers in the panel.**
- 6. This receptacle in the front corner of the garage is all wrong. Have it installed properly while other electrical repairs are being made.**

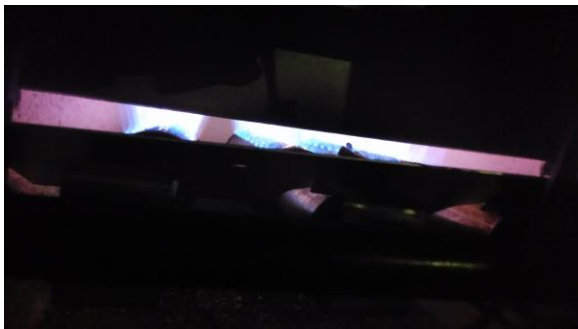
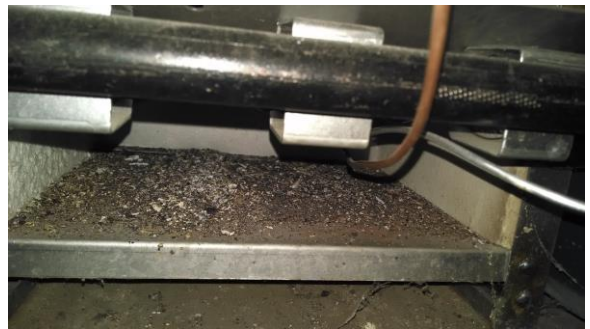
- 9. The boiler is overdue for a cleaning. Remove the bottom cover, simply grab the knobs and lift straight up, turn the gas valve to off, then vacuum the burner tubes and the chamber under them. Relight the pilot and replace the covers. If you are uncomfortable doing this find a plumber or furnace tech you like, it should be done annually.**

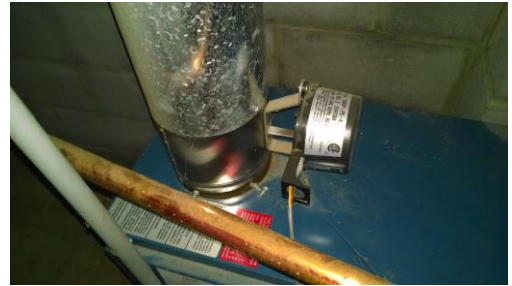
**10. The boiler is equipped with an electrically controlled damper. It opens when the boiler is operating to allow proper exhaust and closes when the boiler is off to keep heated air from escaping up the flue. Most of these devices are design to open when they fail, but some of the early ones were not. It is critically important to maintain the CO alarm in the basement while this device is in use.**

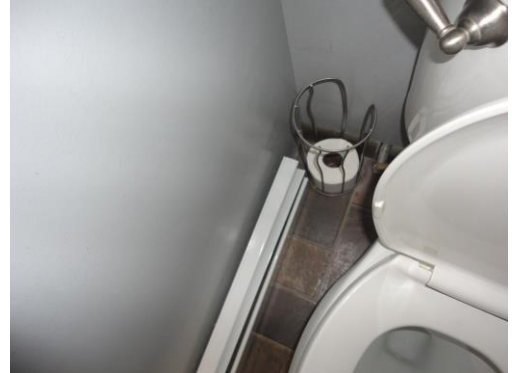
**11. Several of the convector end covers are missing. This is only cosmetic, but these parts are generally not available. Replacements will be difficult, if not impossible to find.**

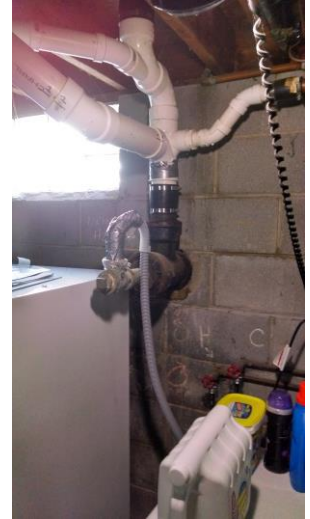
- 14. The toilet in the main bath is loose. It moves a lot. Repair will require removing the toilet and replacing the wax ring. This is a \$6-8 project that should take about 20 minutes, maybe an hour if you have never done it before. Do not put it off. The wax ring could leak destroying the flooring and damaging the structure, the toilet could break, or both – costing hundreds or even thousands to repair.**
- 15. The pedestal sink in the master bath is loose. There are two lag screws under the bowl in rubber bushings that need to be tightened.**
- 16. The washing machine drain is configured in such a way that any sewer back up would overflow out the stand pipe (the part covered in duct tape), fill the washer, or both. My best guess is that it was configured this way after the utility sink and lift pump were removed. Have it repaired by a licensed plumber.**

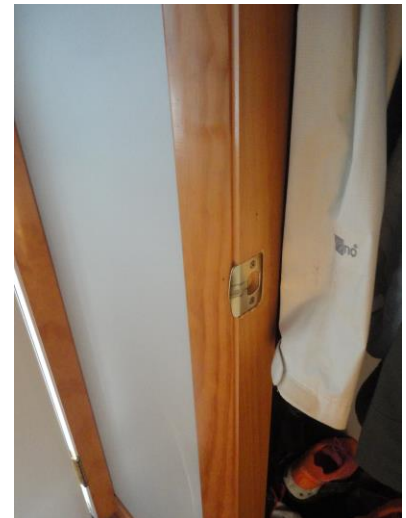
- 17. The front and rear entry doors bump into the jambs along the top half of the lock side. Adjust the top hinge by replacing one or two of the screws with 3 or 4" screws secured into the framing. If this does not work a cardboard shim can be placed between the bottom hinge and the jamb.**
- 18. The closet door in the front hall is missing stop trim that would prevent it from swinging beyond the latch. If not fixed the hinges could very easily be ripped from the door or frame causing a couple hundred dollars of damage. A 4-6" scrap of trim at the latch would be adequate to prevent this.**

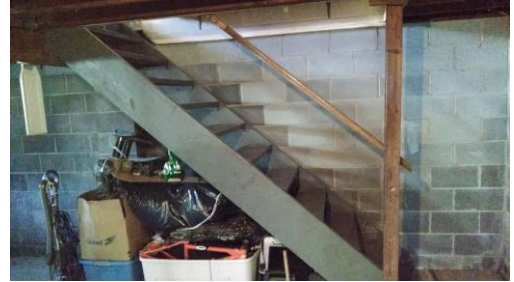
**20. The basement stair handrail is broken mid-span and has been patched with tape and tacks. The replacement rail should include adequate support in the center and provide a guard to keep people and objects from falling off the side of the stair.**

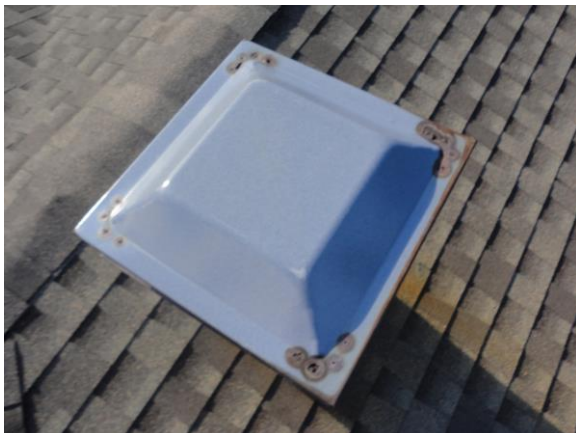
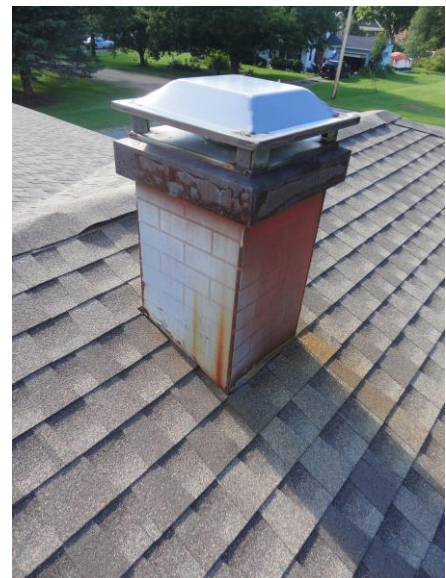
- 23. The steel chimney chase is badly rusted. There are holes around the rivets that support the cap, and the shell and flashing are creating rust stains on the new roof cover. You could bondo, sand and paint the chase and cap; or remove it and patch the roof with new shingles, a proper boot and storm collar, and a cap for the flue. I recommend the latter, and do it soon before the shingles really seal down.**

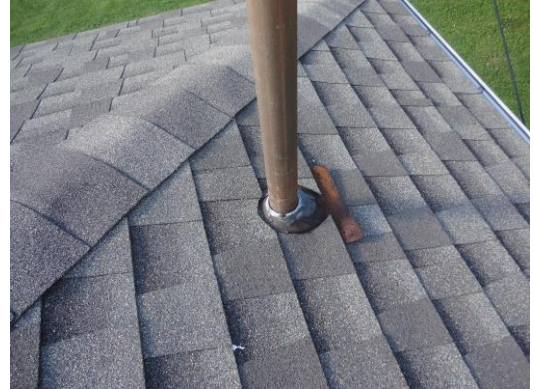
**24. The flashing boot on the electric service mast is rusted and the neoprene gasket is completely rotted off. The mast boot is routinely ignored during re-roofing because there isn't an easy way to replace it. I would caulk the boot opening to the mast with NPC Solar Seal, available at Springville Door and Window or House of Steel for about \$6 a tube. It is designed for this type of application. Painting the boot couldn't hurt.**

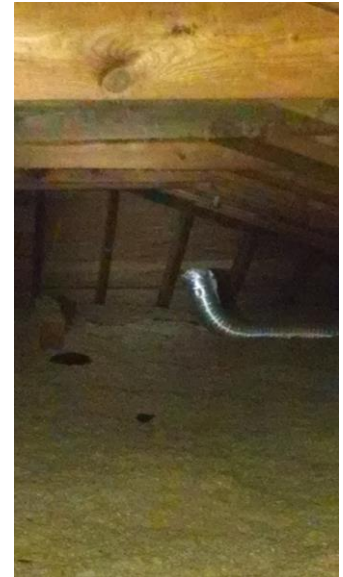
**25. The exhaust fan for the main bath is ducted into the attic on top of the insulation. The master bath fan duct isn't visible, and is either missing or routed to a soffit vent. Both fans should be ducted to the exterior through the roof. Dumping that much moisture into the attic can cause water damage to the insulation and ceilings, condensation and lead to mold growth. Make sure whoever repairs these rakes the cellulose insulation back into place as they exit the attic.**
