**Clear Creek
Home Inspection Services
PO Box 565, Collins, NY 14034
716-864-1231**

**Inspection of 9322 State Road
Prepared for Mrs. Home Buyer
September 30, 2012
12:00-3:30 pm
61° F, Cloudy**

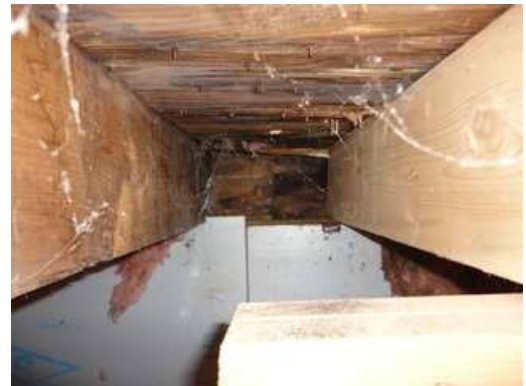
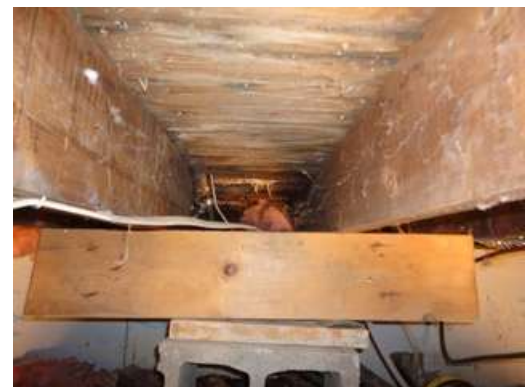
The framing is a little bit light, even by 50's standards, but adequate and reasonably sound. A beam was added at about the center of the living room to stiffen the floor, and another more substantial one placed under the utility room to handle the weight of the well and water treatment equipment. There is some water damage in this area that will need to be addressed.

- 1. There are at least two joists with rotted ends, around 3' of band joist and almost as much sill plate that need to be repaired and/or replaced. These are located under the utility room. One joist has already been sistered in this area.**
- 2. The 'extra' beams are not permanently footed or attached to the joists, and the one under the utility room is on a concrete block that is oriented on its side. Make repairs so that these are no longer needed.**

Remove and replace all the rotted wood under the mechanical room.

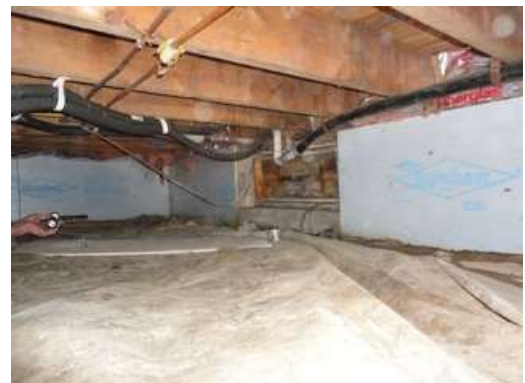
The crawl is reasonably clean and dry considering all the refitting that has gone on down there. There are a few spots where the dirt floor is soft and gives under pressure, and some dampness around a large rock outcrop. The perimeter walls have been insulated with ½" foam (approx. R-3) and the front and back band joist has fiberglass insulation, the sides have none. There is some small debris, a few pieces of drain pipe and some small scraps of wood that should be cleaned up while you are in there for repairs. The heat exchanger from the original floor furnace is down there and is far too large to remove.

- 3. The vapor barrier on the crawl space floor should be continuous and cover 100% of the soil. The seams should overlap 6-12" and be glued or taped. The plastic should be at least 6 mils thick, and extend 4-6" up the walls and any piers or other objects that penetrate the floor. The vapor barrier should be corrected after all other repairs in the crawl are completed.**
- 4. Ventilation and insulation. What little insulation there is in the crawl is being defeated by the vent and a poorly fitting hatch cover. A crawl space should be either inside or outside the building envelope, the current configuration has it a little of both. I recommend sealing the vent, completing the perimeter insulation, and insulating and weather stripping the hatch.**

Repair the vapor barrier in the crawl.

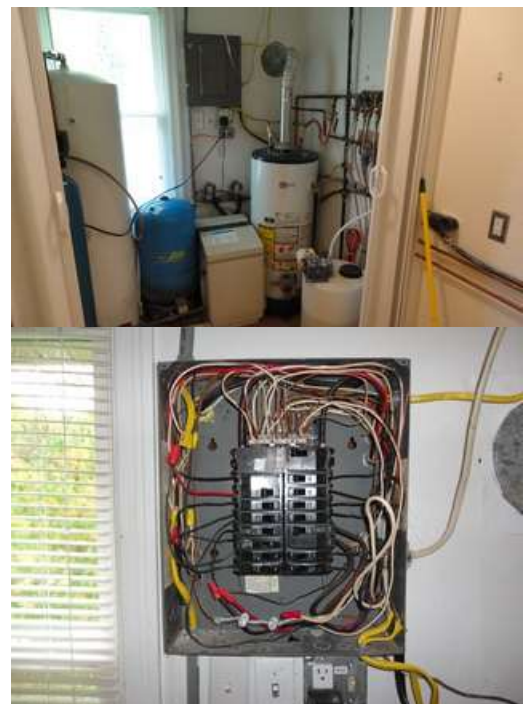
I opened the service and sub panels and examined the branch circuits and overcurrent protection. The main panel is full to capacity, and has several unused circuits terminated within it. The panel and all of the visible cables are far newer than the house. There is no evidence this upgrade was inspected.

5. **The panel is located above the water softener and water heater. The NEC requires at least 3' of clear working space in front of all electric panels.**
6. **There are several unprotected and poorly supported cables at the panel.**
7. **Although all of the visible cable provides an equipment grounding conductor, I located several receptacles with open grounds. Some of these circuits are on the original 2 wire cables and at least two are the result of loose connections. The 2 wire circuits present a shock hazard and should be GFCI protected and labeled. The loose connections can lead to overheating or arcing conditions and are a significant fire hazard.**
8. **There are several poorly supported and unprotected wires in the attic and crawl.**

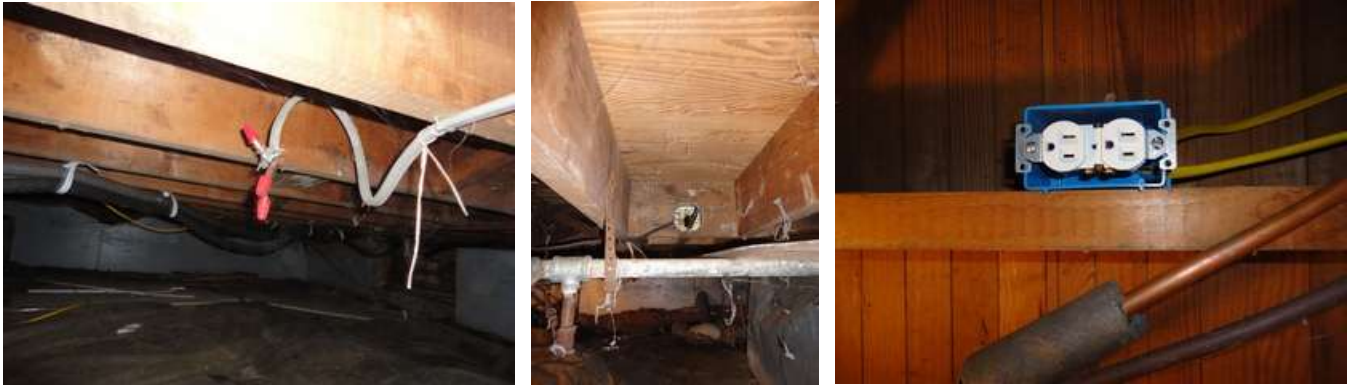
- 9. There are multiple work boxes in the crawl space that are missing covers, and at least one abandoned cable.**

Install appropriate covers and work boxes where they are missing.

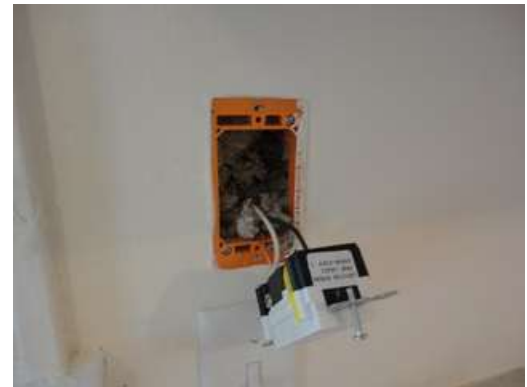
- 10. There is at least one receptacle mounted in remodeling fixture that is open to the wall cavity. The GFCI is in full contact with the cellulose insulation. Install a proper work box.**

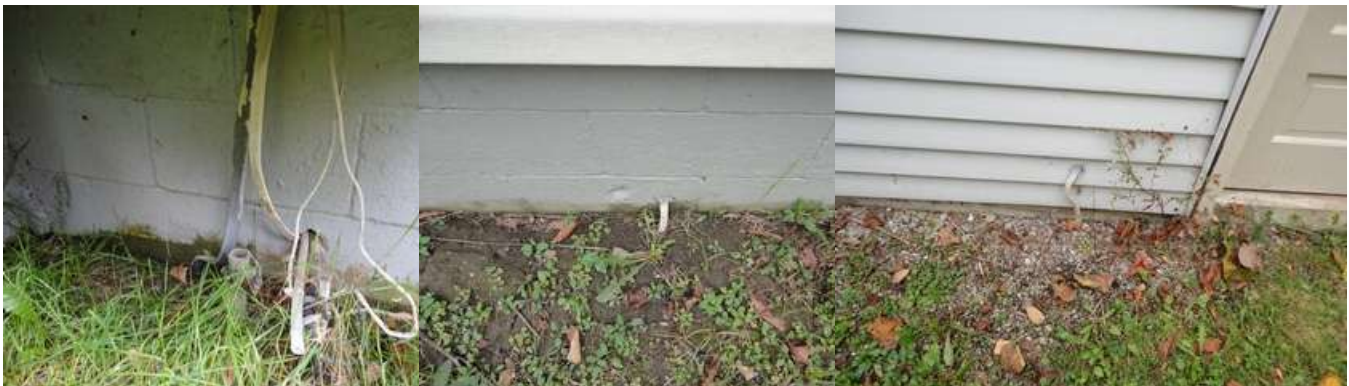
- 11. The underground feeder for the garage is exposed and unprotected in 3 places. While the Type UF cable is rated for exposure to sunlight, it must be protected from physical damage. Also, given its bizarre routing -out the wall, back into the crawl and out the other side- it likely isn't buried to the correct depth either.**

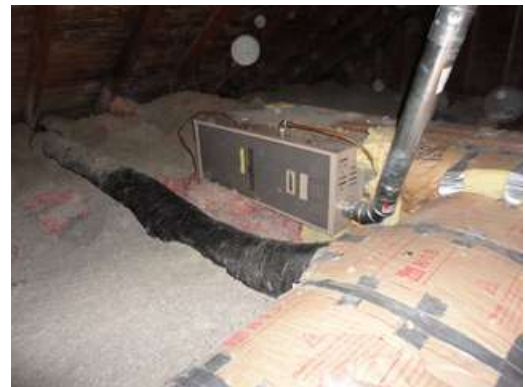
14. Furnaces located in attics are required to have permanent access including a walkway from the hatch to the unit that is at least 24" wide and a platform in front of the unit no less than 30" square. The only way to access this furnace is by climbing on it.

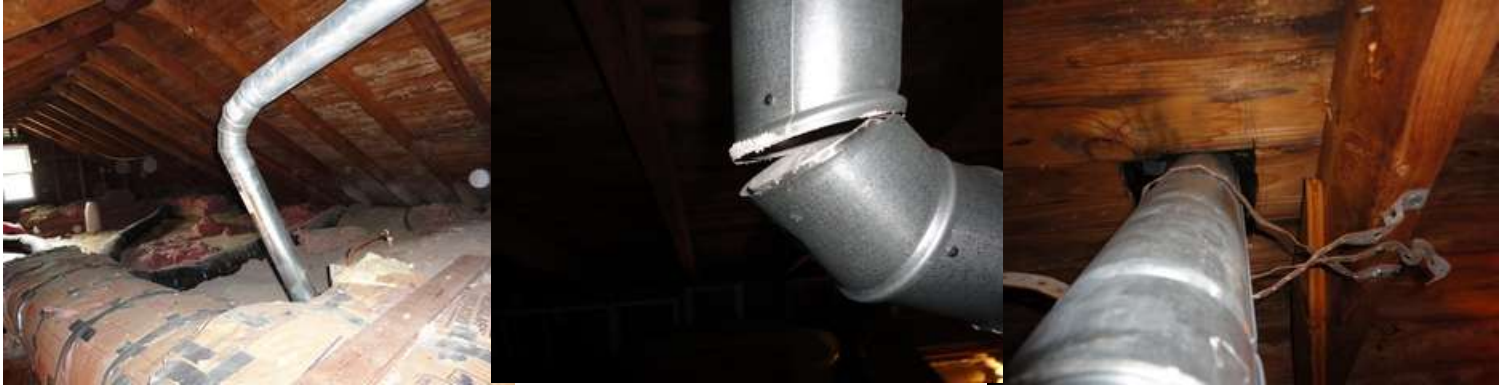
17. The B-vent is poorly supported, the whole stack moves when touched and one of the elbows is broken spilling lots of exhaust (read CO and water vapor) into the attic. It also is far too close to the roof deck where it exits the building, the label on each piece of vent pipe clearly states 1" clearance to combustibles.

Repair all of the exhaust defects on the furnace and the water heater.

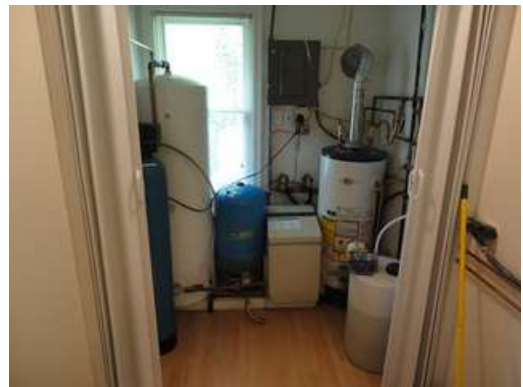
19. The water heater is a Flammable Vapor Ignition Resistant unit built in June of 2006. FIVR water heaters require greater clearance than older tank style units. If the burner senses flammable vapor or a lack of supply air it will permanently close the gas valve. These clearances have not been maintained. I have located the installation manual for this unit for your convenience.

20. The utility room is not large enough to supply adequate combustion or make up air for the water heater, adding a drier will further reduce the available air. Provide air intakes as outlined in the installation manual. Don't forget the drier requirements.

Provide a means of combustion and make up air for the water heater and the drier.

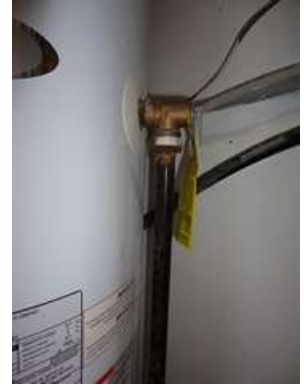
21. Reconfigure the water heater vent so that the horizontal section where it exits the building runs up hill rather than down. The specific pitch requirements are in the manual. Secure the vent with screws.

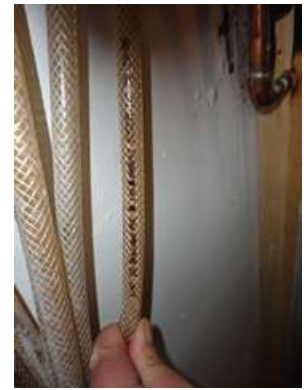
23. The water distribution is via 1/4" reinforced PVC food service tubing. Water supply and distribution pipe must conform to (National Sanitation Foundation). NSF 61. Reinforced clear PVC tubing isn't on that list. All of this tubing should be replaced with an approved material of a suitable size with appropriate support.

Replace all of the plumbing from the pressure tank to the cast iron drain stack, including the softener unit.

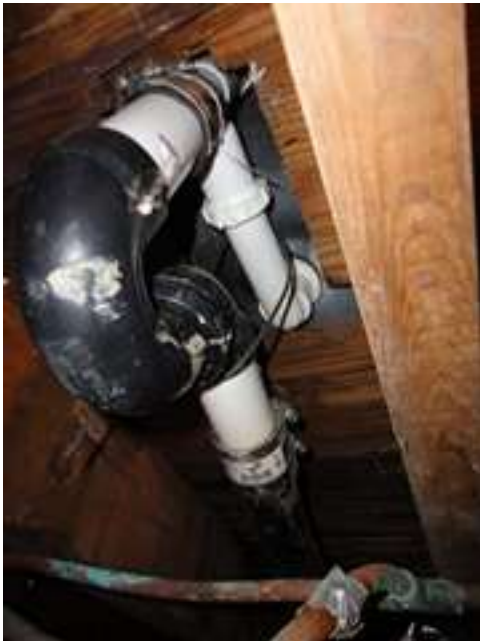
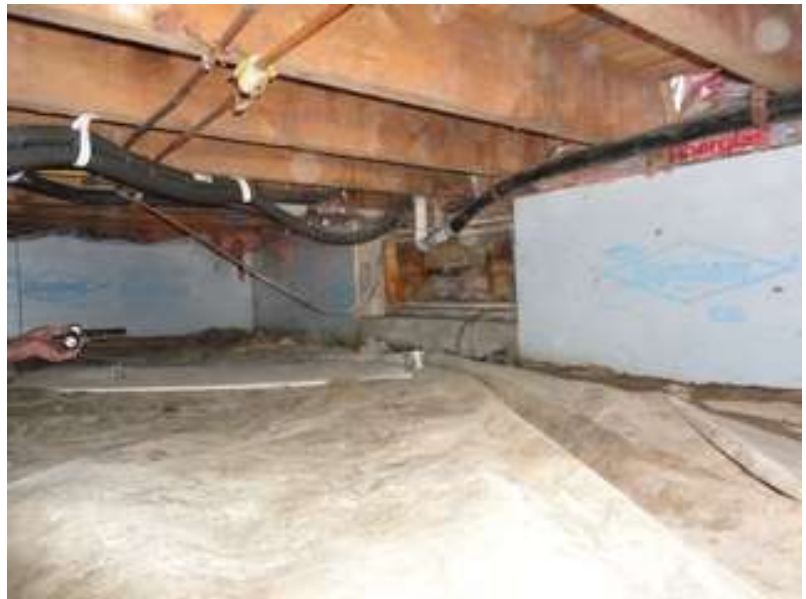
24. The Drain Waste and Vent piping consists of multiple dissimilar materials with poor support and several sections are pitched in the wrong direction. None of the fixtures are vented. The riser for the washer doesn't have a trap. Replace all of the DWV piping up to the original cast iron stack, and provide proper ventilation.

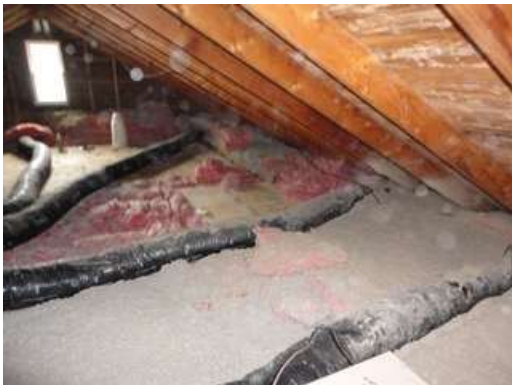
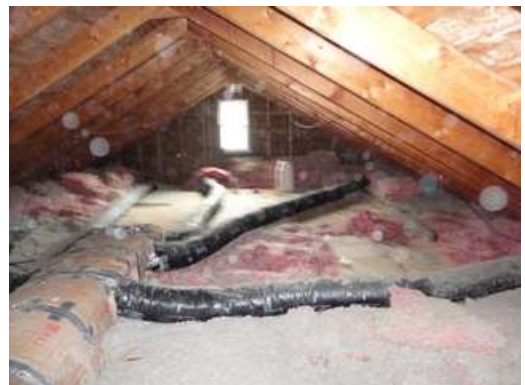
The attic has 3 ½" of fiberglass insulation with some loose cellulose and extra glass batts stacked around the perimeter to cover the heat registers for around an R-15. The roof is in good condition except for a few nail pops around a repair on the South side and two loose shingles on the North side.

26. The attic should have around R-40 insulation in our climate. Add insulation, preserving access to the furnace, and cover the attic hatch.

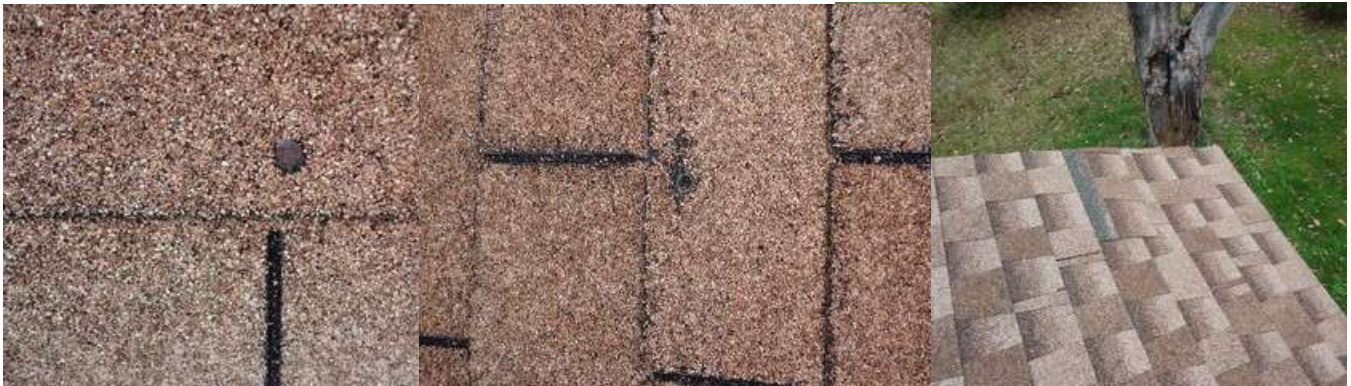
27. Remove and replace popped nails and patch with an appropriate mastic. Refasten the loose shingles.

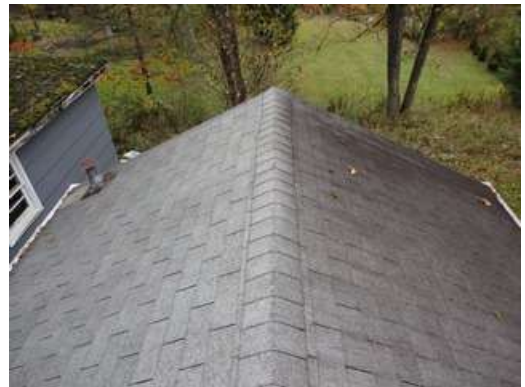
28. There is moss on the front porch roof, and on the North slope of the garage roof. A solution of bleach and water will kill the moss and it will sweep off easily when it's dry. Removing the moss will extend the life of the cover.

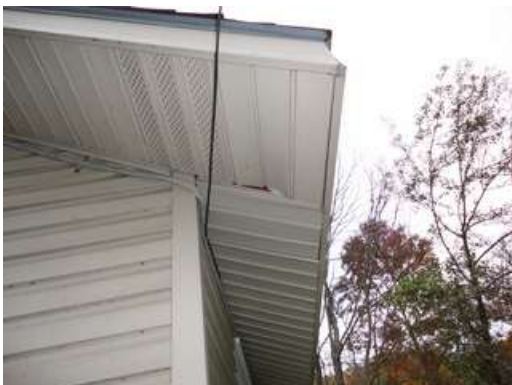
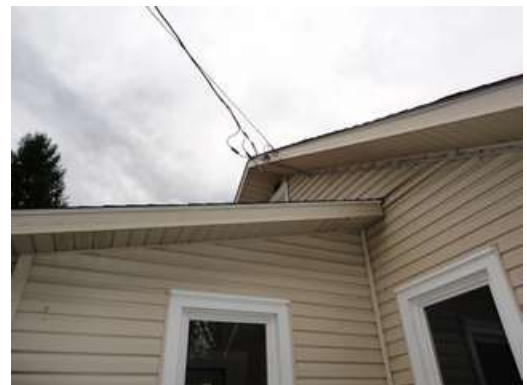
29. Repair the gaps in the siding and trim and touch up the exterior caulking.

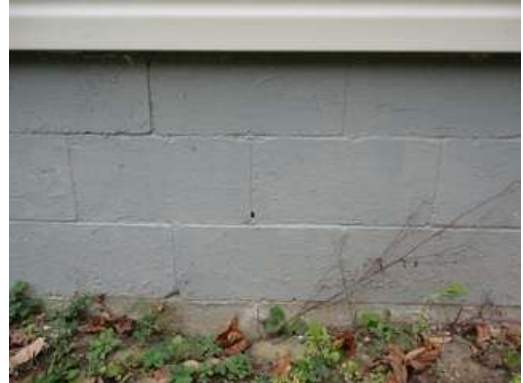
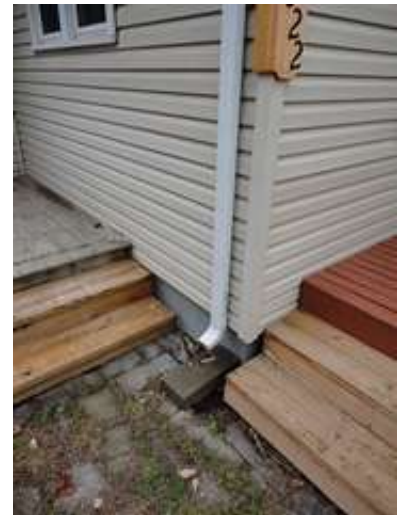
31. The downspout on the front corner dumps right onto the entry for both decks. This is too close to the foundation and has to be very icy in winter. Install a buried drain to get the water away from the house and the stairs.

32. Install gutters and downspouts where they are missing, and make sure to drain them well away from the house.

Install gutters and downspouts and fix the ones that are there.
