2100 Any Road, Your Town, NY
Confidential Report. Prepared for the Exclusive Use of (your name goes here)
Date of inspection

**Clear Creek
Home Inspection Services
PO Box 565, Collins, NY 14034
716-864-1231**

**Inspection of 2100 Any Road
Prepared for (your name goes here)
Date of Inspection
8:00 am-11:45 pm
55° F, Cloudy with recent rain and high winds.**

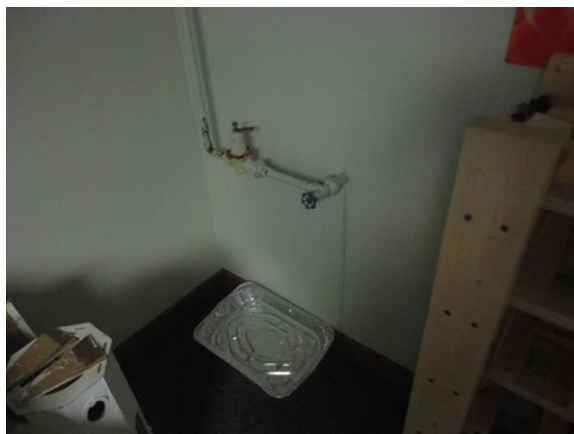
- 1. The water main enters through one of the finished walls and has some seasonal condensation issues. There are drip stains on the wall and on one ceiling tile. There was a pan there to catch drips. I recommend insulating this pipe from where it penetrates the drywall, above the ceiling tile, to a foot or two into the unfinished portion of the basement.**

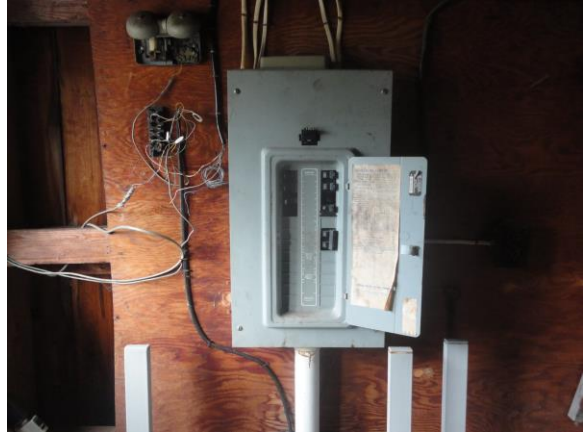
6. **The homeowner indicated there was a switch outside the kitchen to turn off the smoke alarm circuit to prevent nuisance tripping while cooking. Remove it. The NEC does not allow any switches in alarm circuits.**
7. **The Garage electric panel is a Federal Pacific Electric device that is known to be a fire and safety hazard. To add insult to injury, it also has several installation defects. Make sure this panel gets replaced.**
8. **Current code requires all garage outlets to be GFCI protected.**

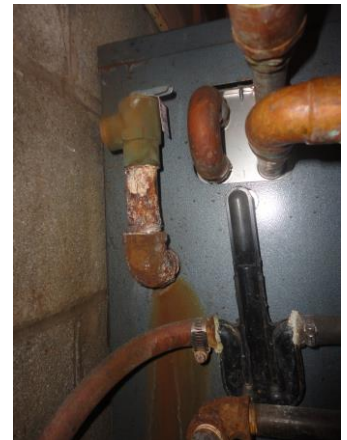
11. **The cooling system air handler is lacking a pan and secondary condensate drain. There is evidence of condensate overflow on the air handler platform and on the ceiling below.**

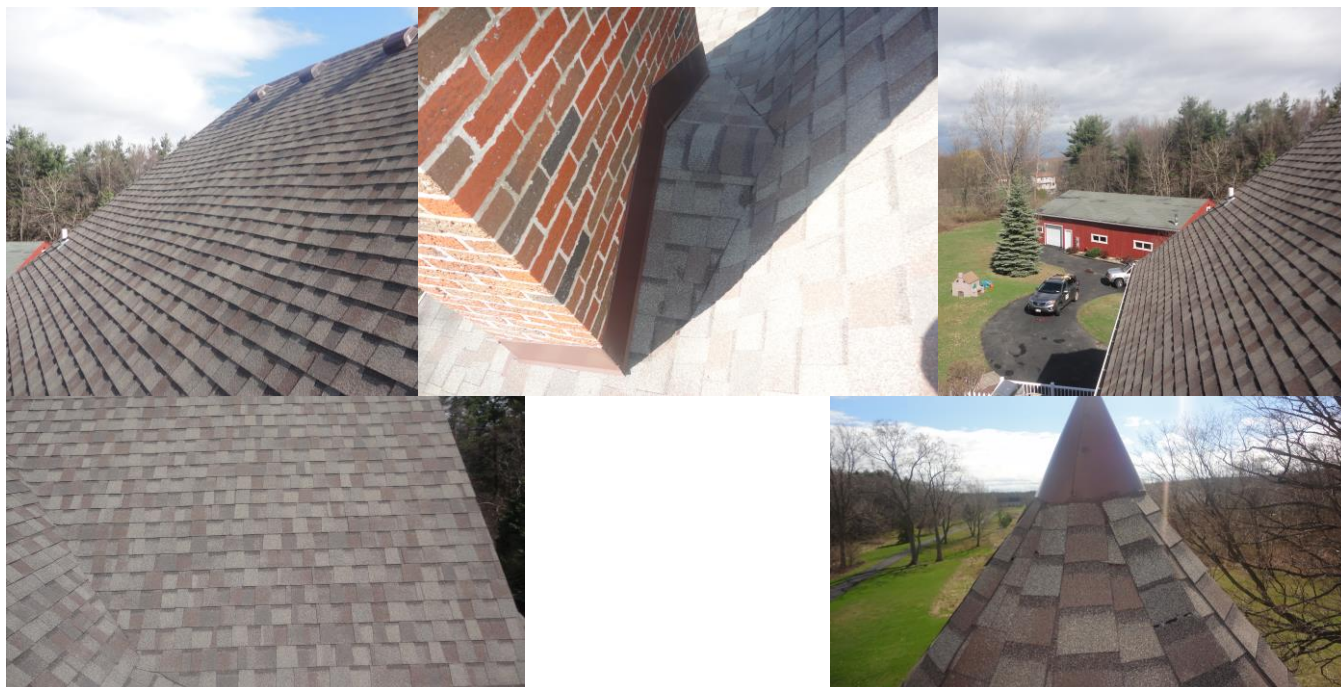
The homeowner states the roof was replaced in 2013. It was very nicely done. There are new flashings, new edge trims and very well executed new reglets on the chimney.

Here is a look at the workmanship up top that you may not otherwise see.

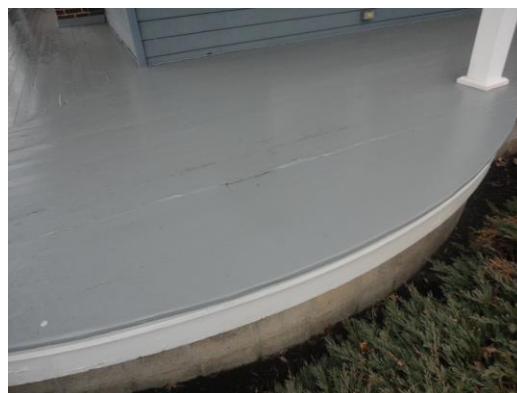
18. The lower front porch sits over a concrete block crawl space that has operable vents installed. The wood flooring is buckling in a few places and exhibiting signs of rot in others, primarily because the vents are closed. Open the vents and back prime any new wood you put on the floor.

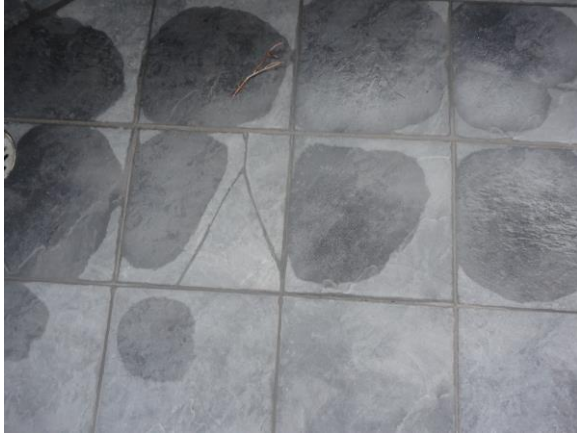
19. There are several loose tiles on the second floor porch, and at least one that has cracked.

**Broken tile on left, loose one on right.
Near drain at the round section.**

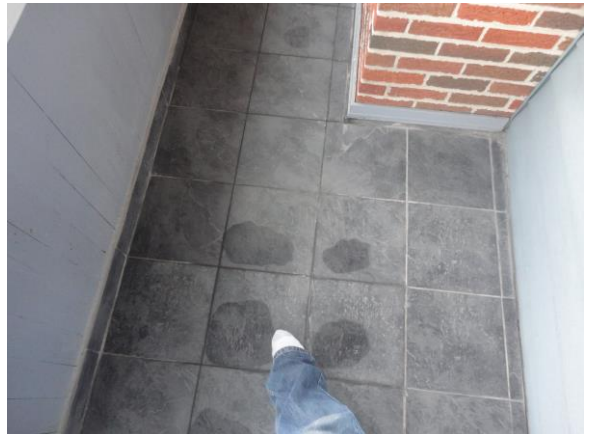
These 4 wet tiles are loose.
